Gila River Health Care  
Red Tail Hawk Water Production Facility

Technical Memorandum 1  
PRELIMINARY ANALYSIS AND  
COST STUDY

DRAFT | December 2018

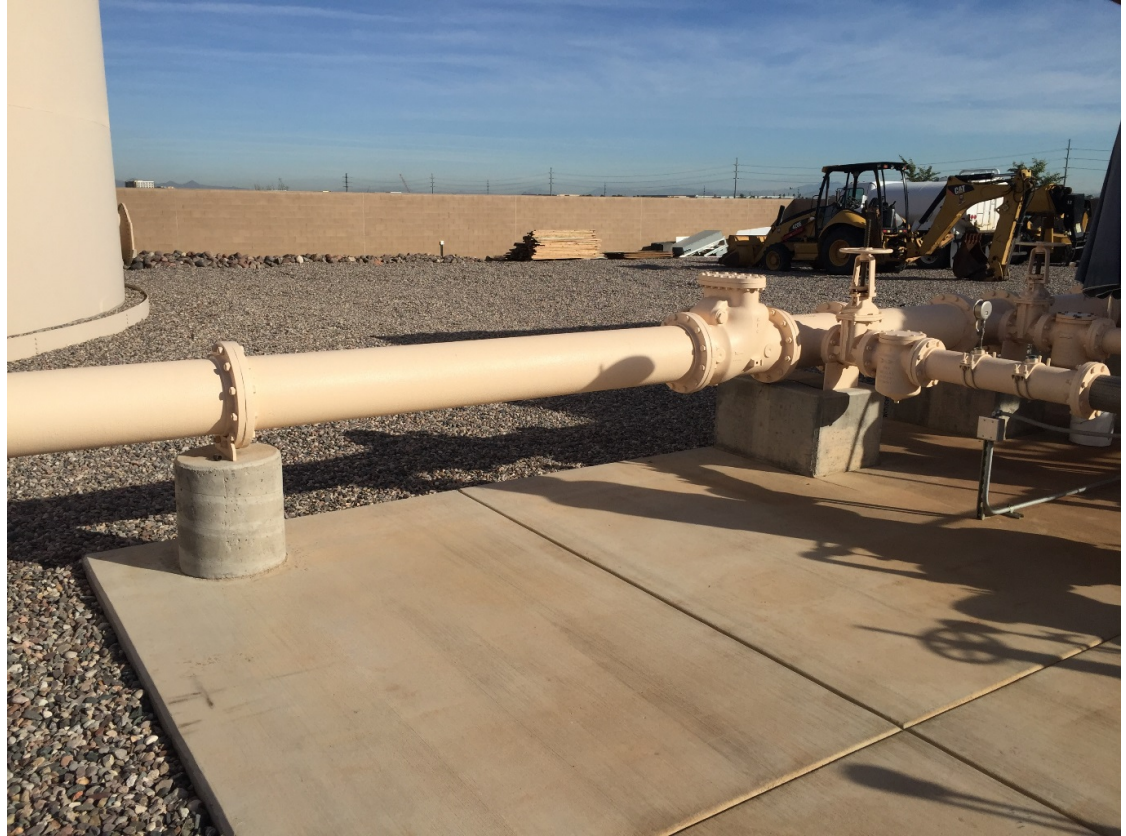
Figure 1.2 Health Center Water Production Facility Site Typical Ground Cover

The site was covered by small rocks and riprap for drainage. Figure 1.2 illustrates the typical ground cover at the site. Based on visual inspection and anecdotal information, there do not appear to be any significant drainage issues on-site. Operations staff noted that tank overflows and drains are adequately evacuated from the site to the adjacent farm land via the rip rap and drain block in the perimeter wall. Ground cover was sufficient for the site usage.

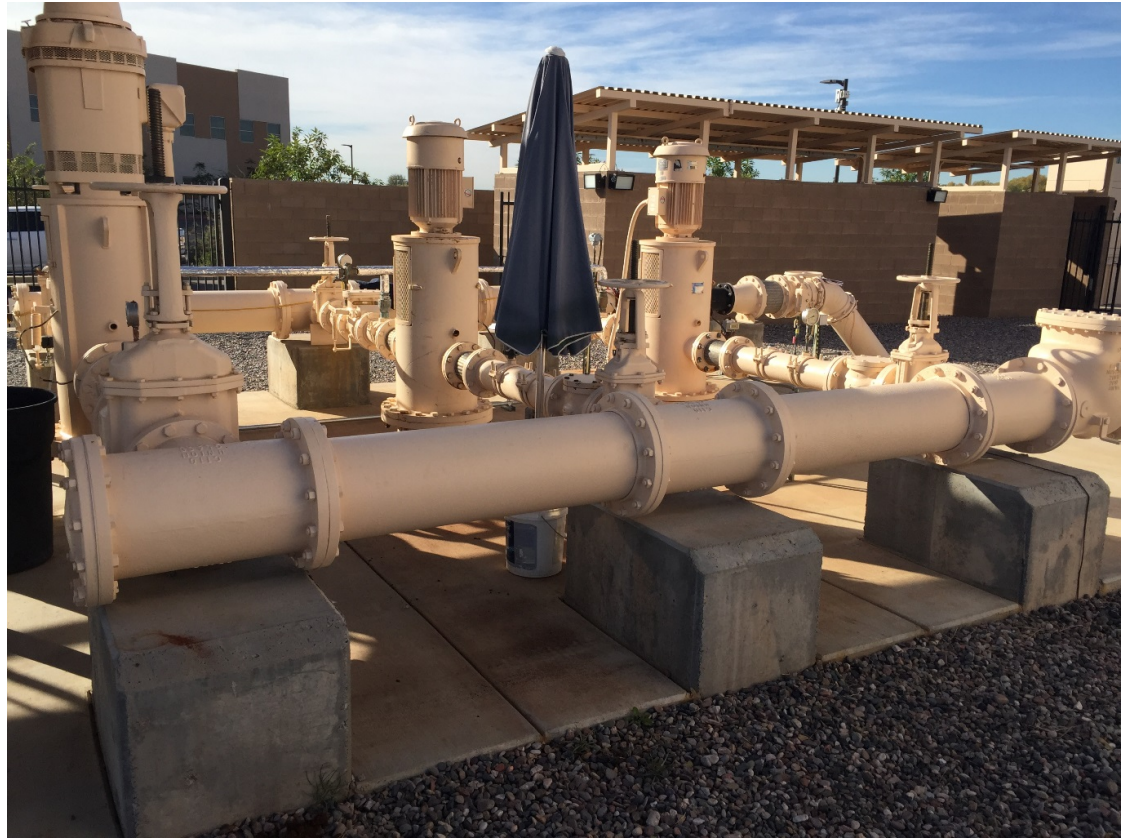
Figure 1.3 Health Center Water Production Facility Booster Pump Station

- **Misc. Issue 1:** *The current booster pump station pipe supports do not meet design standards.*
  - **Misc. Recommendation 1:** Install pipe supports on all three booster pump suction and discharge pipes adjacent to the expansion fittings to provide appropriate support during all operational conditions. The existing booster pump station is shown on Figure 1.3.

7. Replace all direct buried lines with 2-inch containment piping with Teflon (PFA) carrier tubing.
8. Install pipe supports on all three booster pump suction and discharge pipes adjacent to the expansion fittings to provide appropriate support during all operational conditions.
